# EVALUATION OF EXISTING CONDITIONS

## SUMMARY EVALUATION OF EXISTING CONDITIONS

# BURLINGTON HIGH SCHOOL- CODE REVIEW

**Burlington High School**  
**Burlington, Massachusetts**  
**Structural Assessment**  
**May 20, 2024**

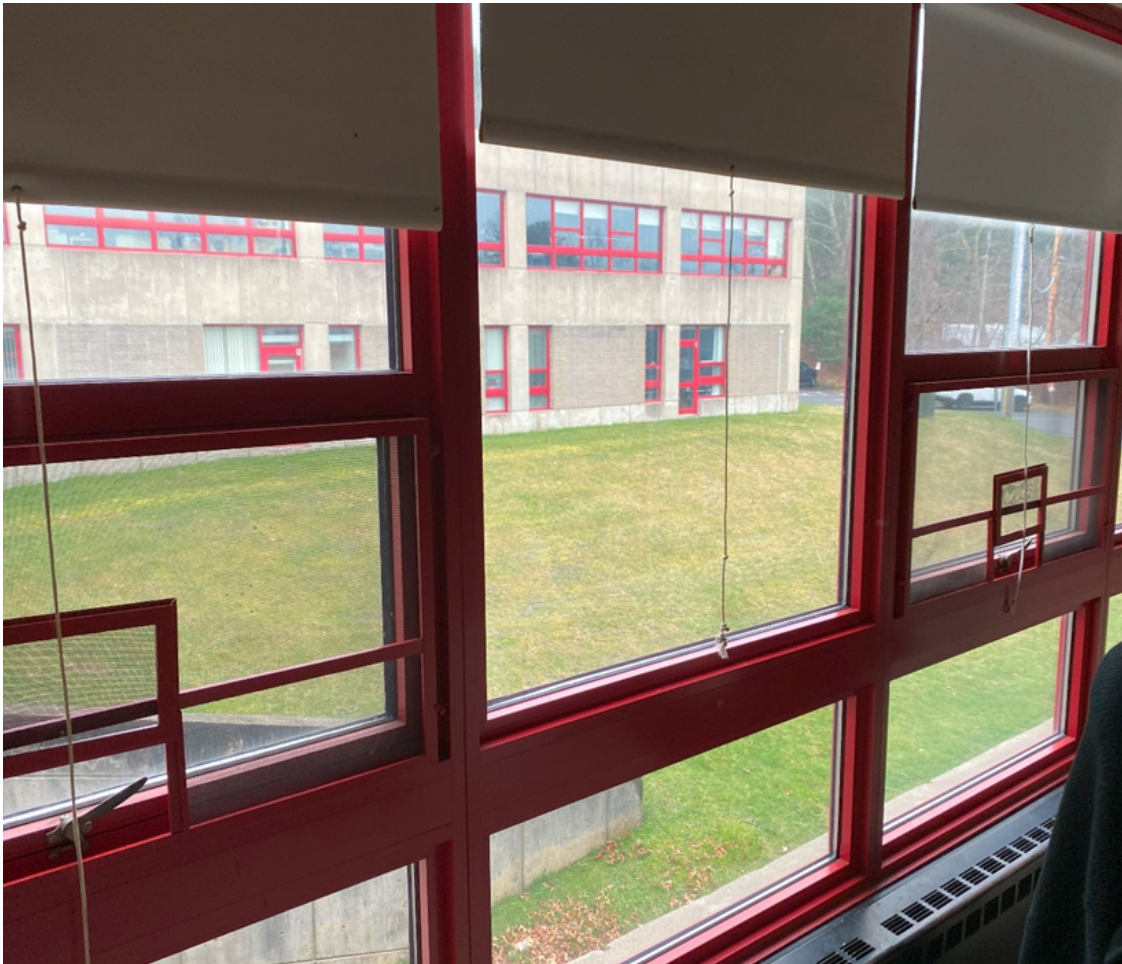
Existing fenestration consists of large aluminum framed ganged windows, with double pane insulated glass and operable venting sashes at the middle portion of the frames. This fenestration is not original to the building but part of window replacement work done in 2000.

While a more in-depth evaluation may be necessary to locate the exact point of failures, it is likely that the perimeter sealants may have exceeded their serviceable time, so it is recommended to replace the perimeter sealant and backer rod at each bank of windows, to reduce air / water infiltration and increase building envelope performance.

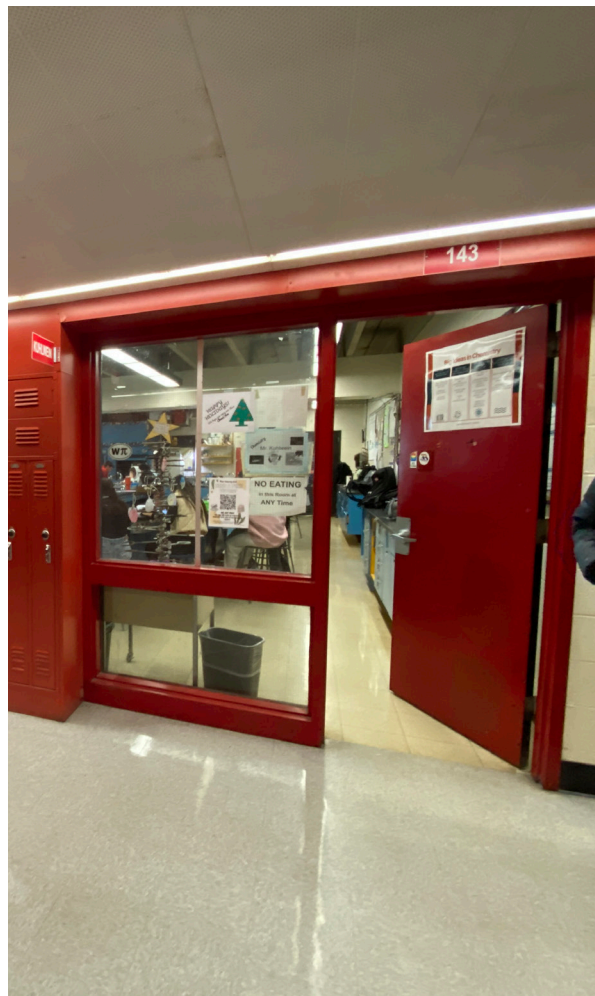
Most doors open into the classrooms, which is acceptable for spaces under 50 occupants. There are some spaces where the occupancy may exceed 50-music rooms for example- therefore the door swing must be in the direction of egress.

**Hardware may need selective or complete replacement to comply with applicable accessibility code requirements, life safety requirements and user requirements for student and staff safety based on school security protocols.**

**It is assumed that a number of doors will require replacement given the age of the building and condition of many doors, and the need in certain locations for abatement.**

**Doorknobs need to be replaced.**

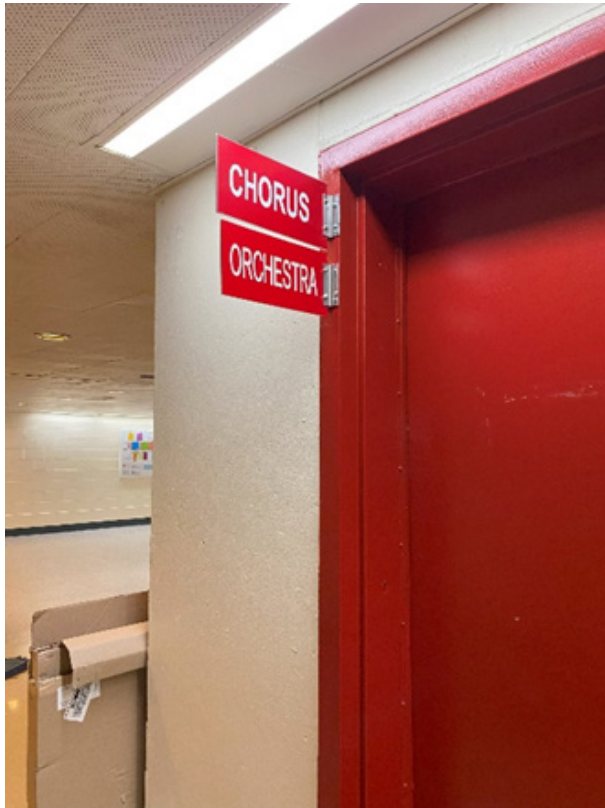
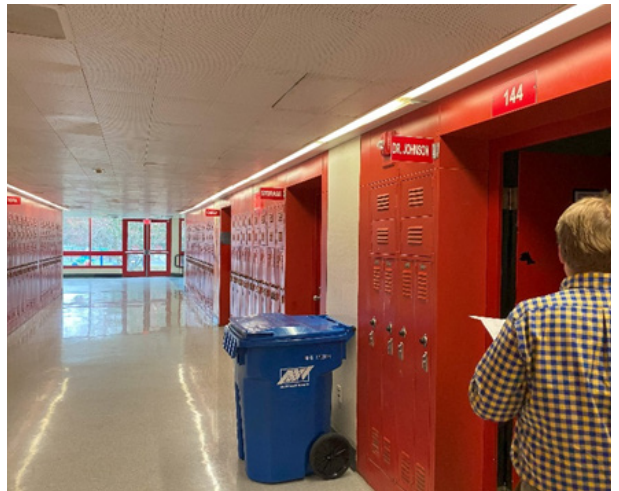
Currently many of the room signs are mounted on the doors, which is not in compliance with MAAB.

**Signage needs replacement to meet MAAB requirements and to address proposed room numbering.**

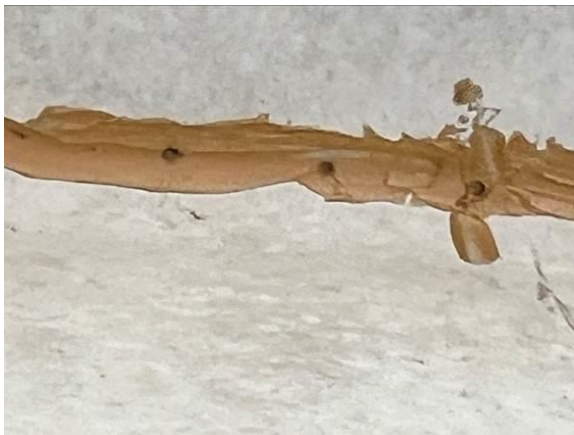
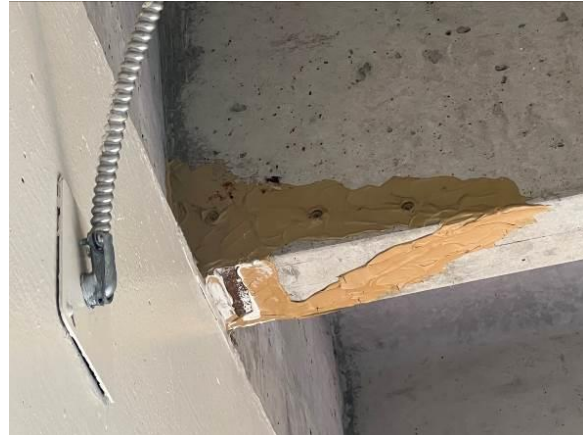
We observed some signs of leaks in the ceilings. We observed cracks in the stems and flanges of the exposed precast concrete double tees that have been repaired in the past. We did not see any connections between the top of the interior masonry walls and the structure.

**Example of past repairs to the flanges and stems of the precast concrete double tees**

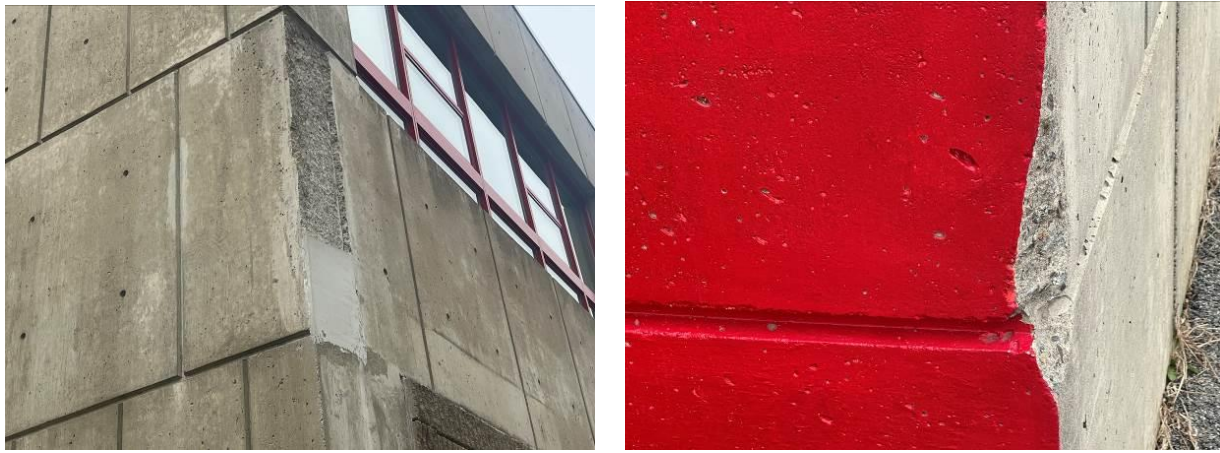
The exterior façade is cast-in-place concrete for the most part, we observed some damage to the walls at the corners and observed past repairs to the surface of a portion of a wall where the original concrete has spalled.

**Damage to the exterior concrete facade**

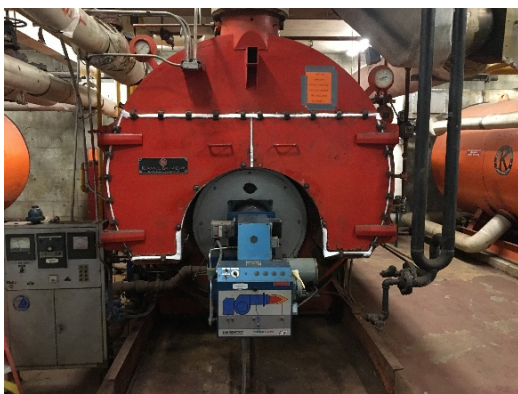
Photo 1 - Boiler

The existing mechanical room is located toward the back, lower portion of the building. The mechanical room is equipped with three (3) gas fired, fire tube boilers, Kewanee model H2W-300-K boilers, rated for 300 boiler horsepower each. There are three (3) hot water lead/standby base mounted circulating pumps which pump water to eight (8) secondary single primary pumps within the building serving the building heating systems. The existing boilers, pumps and associated equipment were installed back in 1972 and are in various levels of disrepair.

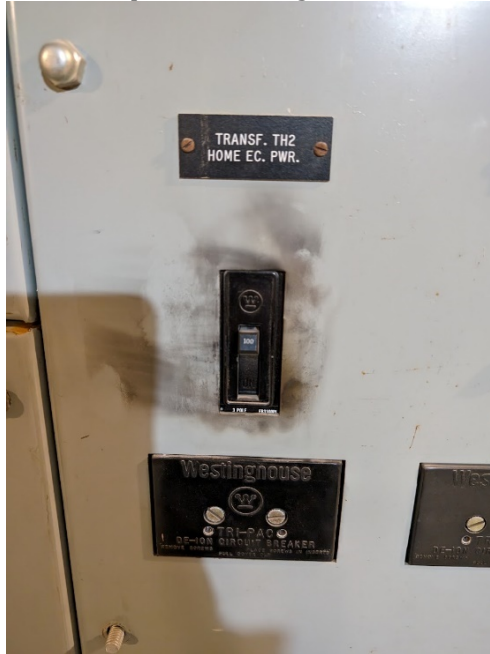
- The main electrical service is split into three separate distributions.
  - Distribution 1 is via a pad mount utility transformer located adjacent to the school. This transformer serves a 3000A, 480Y/277V Main Switchboard located in the lower level of the school.
    - i. This switchboard was far past its recommended life span (manufactured 1971) and had visible past fire damage.

*Figure 1 Switchboard 1 Fire Damage*

- iii. In addition, any parts and pieces for modifications to this switchboard would be costly and hard to acquire due to its age. It is recommended that this unit is replaced in kind.
- iv. There was a power factor correction unit installed as an accessory to the switchboard. This unit was also past its life expectancy. Further analysis could be performed to decide if a new power factor correction unit would be required. The buildings electrical loads have changed since the electrical equipment was installed in 1971 and therefore a power factor correction unit might not be needed.

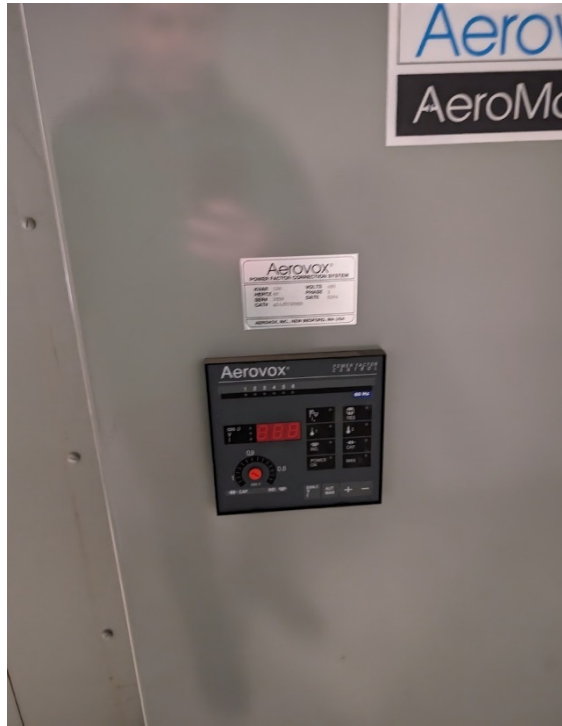
*Figure 2 Power Factor Correction unit SWBD 1 , dated 1994.*

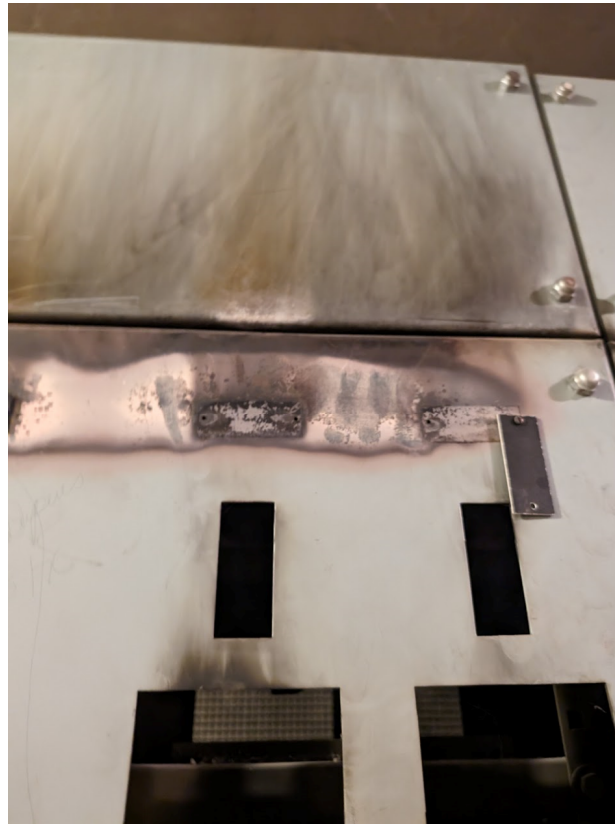
1. This switchboard was far past its recommended life span (manufactured 1971) and had visible past fire damage.

*Figure 3 Switchboard 2 Fire Damage*

2. In addition, any parts and pieces for modifications to this switchboard would be costly and hard to acquire due to its age. It is recommended that this unit is replaced in kind.

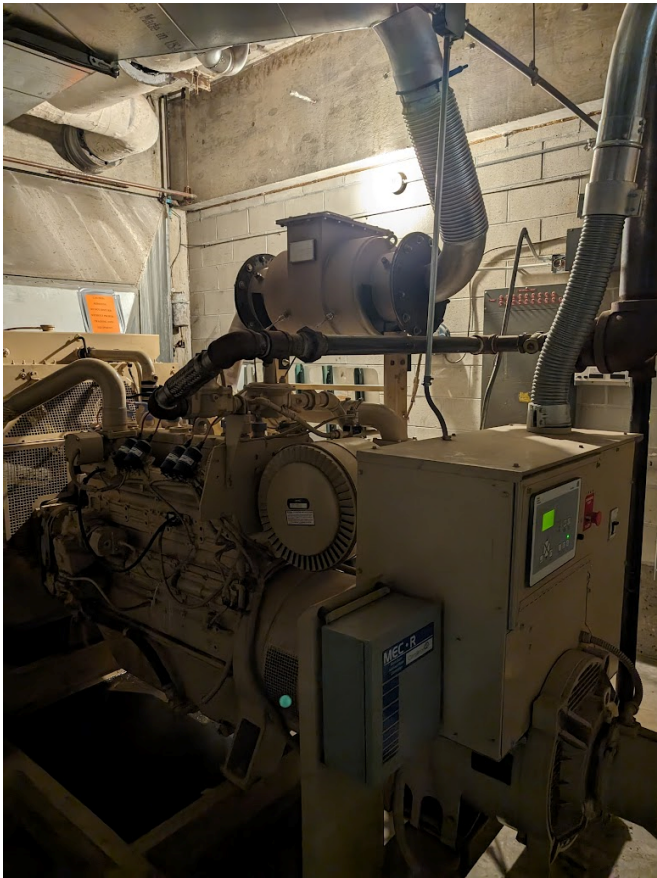
*Figure 4 Generator.*

- The unit is natural gas-fired and a source for on-site combustion. Natural gas generators are not acceptable means of providing emergency power. Natural gas generators typically are rejected by AHJs. Additionally, the required 10s of time for transfer of power via the automatic transfer switch can be hard to attain with a natural gas generator. It is recommended to investigate the possibility of adding a diesel generator.

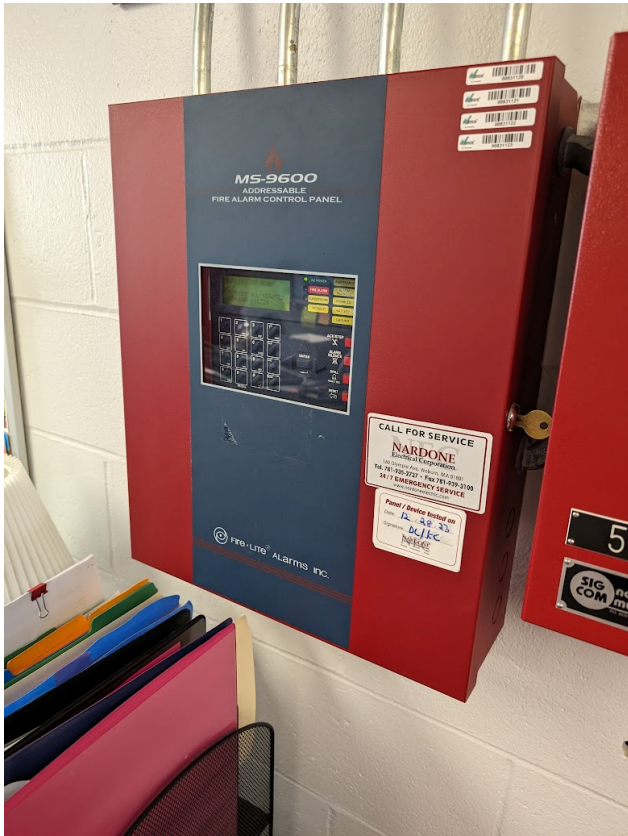
Figure 5 FACP.

- There is a Fire Lite Fire Alarm system. The fire alarm system appeared to be original in some areas and new in other areas. During our brief walk through, fire alarm coverage appeared adequate, however the entire system should be surveyed in detail and corrected as needed. The system should be replace/upgraded to current components.
