BURLINGTON HIGH SCHOOL

Landscape Existing Conditions Report & Site Development Requirements

CIVIL EXISTING CONDITIONS REPORT MAY 28, 2024

Existing Site Utility Infrastructure Narrative

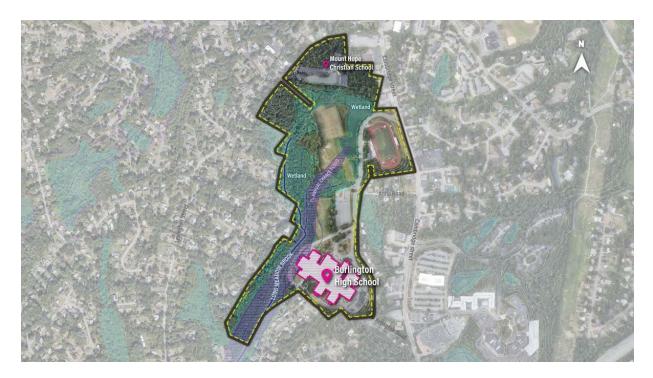
The wetlands border the west and northwest part of the campus as shown in the illustrative graphic below.

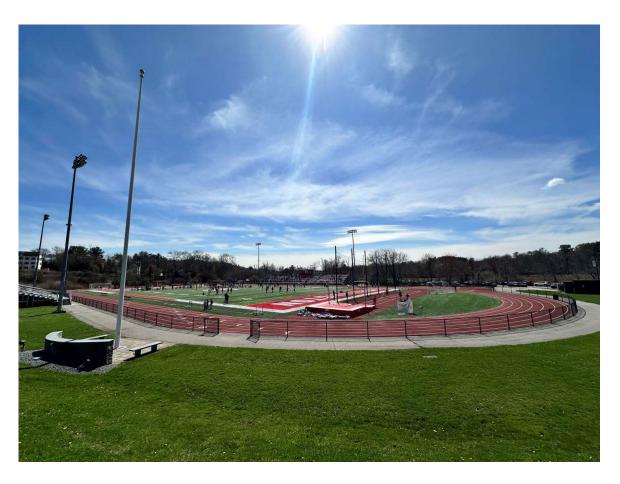
The existing track and field stadium was recently renovated and is in good condition as shown below. It has all the necessary infrastructure from fencing, scoreboard, sports lighting, bleachers and concession.

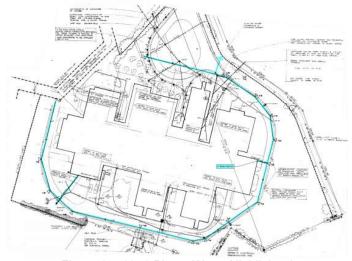
Figure 2 – 1971 Plans, Water Highlighted

The existing school's water service size and location needs to be confirmed with a survey, but some information can be assumed using record plans from the Town and from the site walk. Per these record plans, there appears to be a water line which runs from the west side of the school building, around the south, and then up the east side, where a branch connection appears to connect into Arlington Road. This water line feeds a 4-inch building service at the east side of the school, a 6-inch building service on the south side of the school, as well as several hydrants around the site. Four (4) hydrants were located on the record plans.

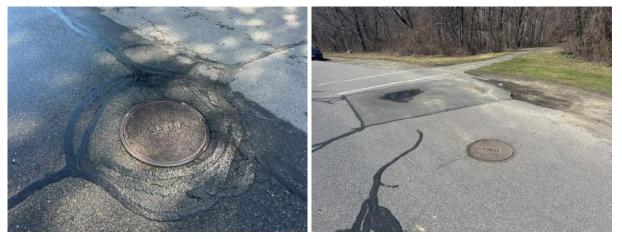
Figures 12 and 13 - Sewer Manholes on the Southwest and West Side of the Building

Two sewer manholes were observed on the site, southwest of the school building and along the west side of the building near the pathway to Valley Circle. The second sewer manhole indicates that there may have been changes or additions to the sewer as designed in the 1971 plans; however the locations seem to confirm that sewer leaving the site likely connects into infrastructure in Valley Circle. There is no evidence of an external grease trap, but a final survey would confirm this as well as the other assumptions based on the town records mentioned above.

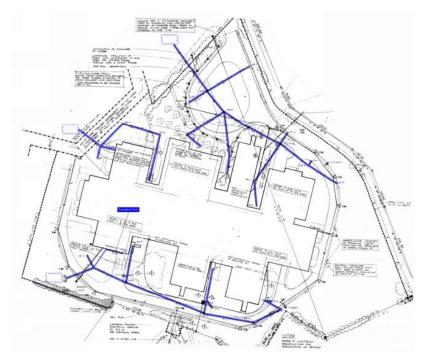
Figure 14 – 1971 Utility Plan, Drainage

The first of the outfalls identified by the record plans are a headwall discharge at the southwest of the site which picks up drainage from the south side of the building and the foundation drain for the building. The second outfall point is west of the building, where the plan indicates that drainage piping continues northwest, presumably to Valley Circle. This picks up some catch basins along the west side of the building as well as a roof drainage connection. Lastly, the third location is assumed to be a piped discharge to the wetland. The record plans indicate drainage picked up by the catch basins in the front of the site continuing northwest, under the grass field, in that direction.

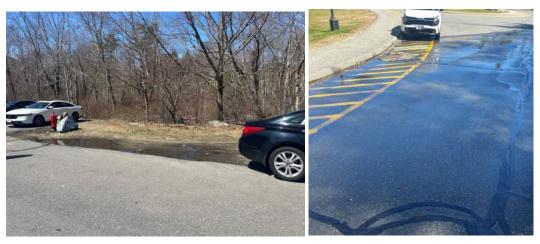
Figure 15 – West Site Ponding

Several areas of ponding concern were brought up by the school facilities during the site walk. It is unclear currently whether the ponding is from surface drainage or from groundwater; however, the amount of visible ledge suggests the latter. Further geotechnical investigations will need to occur to understand the full extent of site constraints for stormwater.

Redevelopment of the school site will require upgrading the existing stormwater management and installing new stormwater management infrastructure to ensure compliance with current MassDEP standards and MS4 requirements. This will require reductions in both stormwater discharge rates for the 2-year, 10-year, 25-year, and 100-year 24-hour rainfall events and water quality treatment mitigation prior to discharge of stormwater to the surrounding wetlands.

Required stormwater mitigation can be achieved by directing runoff to grassed swales, porous pavement, and biofiltration BMPs. A retention/detention element will be required as part of the proposed stormwater design. Due to the lack of closed drainage system in some portions of the site, some mitigation will need to happen with surface basins and/or porous surfaces. Water quality will also need to be addressed as part of the stormwater design.

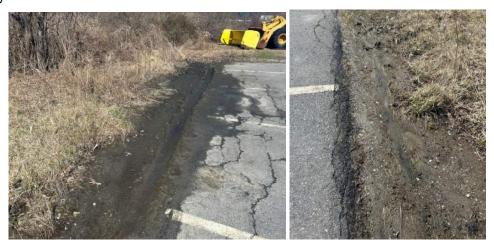
Figure 22 and 23 - Swale

The parking lot to the north of the school drains mostly by sheet flow. A visible swale was present along the wetland side of the lot. Additionally, there were two stone areas at one of the parking islands which are potentially drywells.

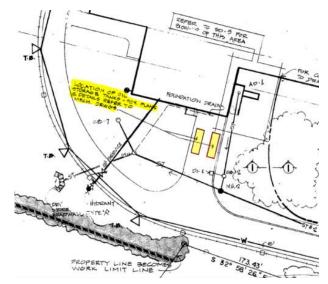
Figure 23 - 1971 Utility Plan, Underground Oil Tanks

The record plans indicate underground oil tanks at the southwest corner of the building. It is not clear whether these tanks still exist or are record. Additionally, national grid markings on the sidewalk and pavement were observed during the site walk.

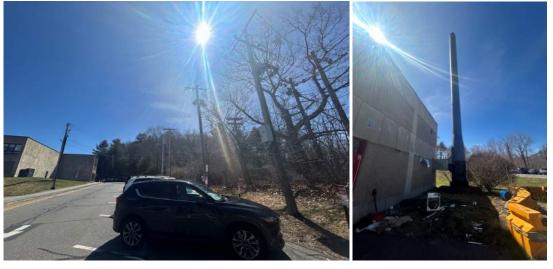
Figure 24, 25, 26 - Site Lighting, Overhead Wires and Electric Manhole

Site electrical appears to come from overhead wires along the west side of the building. Various site lighting was observed throughout the site and may need updates depending on the proposed site plans. Additionally at the west side of the building, there were several trailers and what appears to be a smokestack tower off the side of the building.

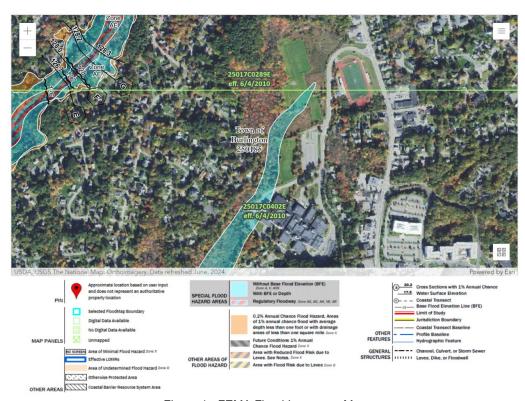
Figure 1 - FEMA Flood Insurance Map

Based on the FEMA Flood Insurance Rate Maps for Burlington (Community Panel No. 25017C0402E and 25017C0289E), the Site is located within the special flood hazard area, Zone A without base flood elevation.

Any work within the Flood Zones will require permitting through the Burlington Conservation Commission.

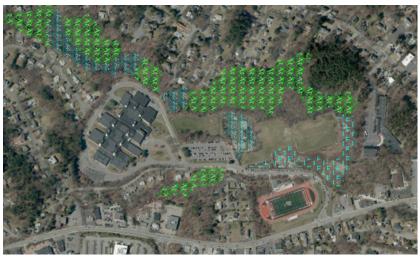
Figure 2 - MassGIS Wetlands Map

According to MassGIS datalayers available on MassMapper, there are several jurisdictional wetland systems associated with the site in addition to the floodplain. These include a shallow marsh meadow wetland system at the northeast of the property (shown in cyan), four (4) wooded swamp deciduous wetland systems shown in green, and three (3) shrub swamp wetland systems shown in blue. No vernal pools are located within proximity to the site. On-site investigations by a wetland scientist will need to occur to verify and confirm these wetland boundaries as well as identify any additional wetland systems on-site.

Any work within the Buffer Zone (100-feet offset) to the wetland systems will require permitting under the Wetlands Protection Act and Town of Burlington Wetland Bylaw, and an Order of Conditions will be required.
