# EVALUATION OF EXISTING CONDITIONS

## SUMMARY EVALUATION OF EXISTING CONDITIONS

# BURLINGTON HIGH SCHOOL- CODE REVIEW

**Burlington High School**  
**Burlington, Massachusetts**  
**Structural Assessment**  
**May 20, 2024**

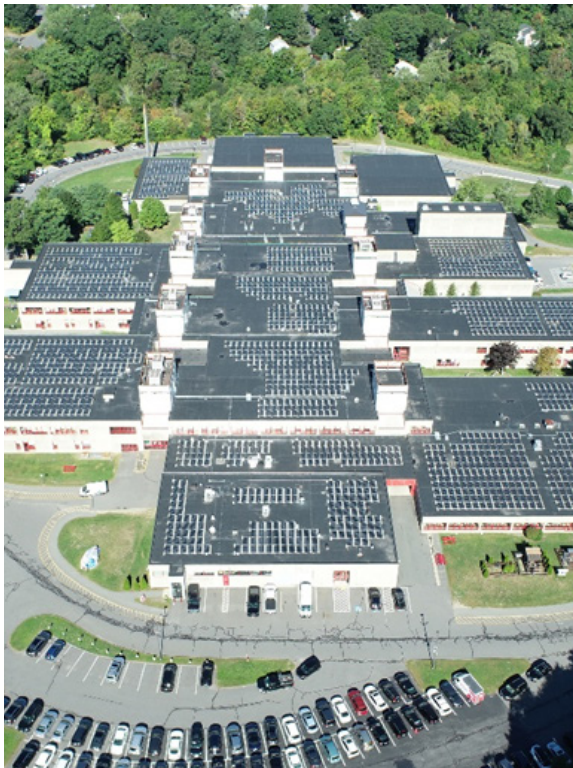
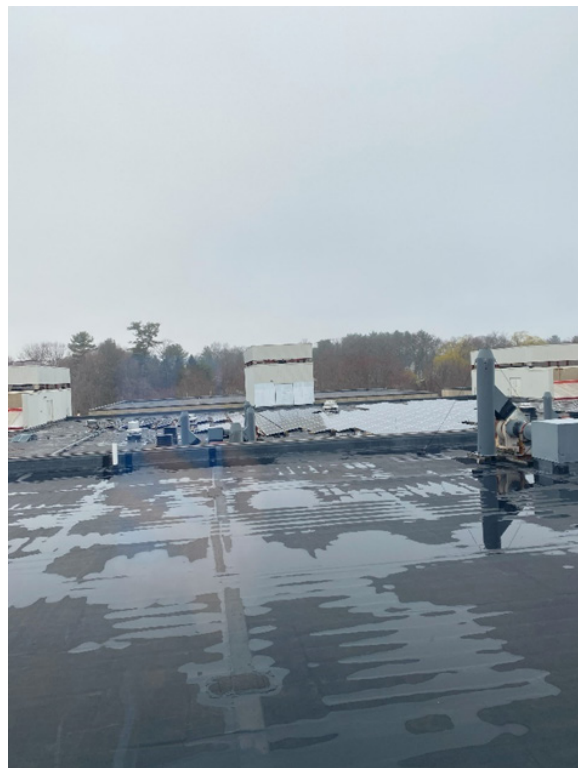
According to the BHS Educational Program provided by the district, the roof is a low pitched fully adhered rubber membrane roof which was replaced in 2011. The roof is mostly covered with photovoltaic panels. There are no known deficiencies with the roof at this time, though signs of aging and bubbling are occurring.

We have no record of any later installation or roof work, so if the current roof is the one installed in 2011, the EPDM still has a number of years left before needing additional work.

**Any roof alterations (beyond basic repairs) as a result of renovation or new work must comply with the current Energy Code. ( 2021 IECC with Stretch Code amendments). Therefore, It is recommended to do a full replacement with Code compliant insulation thickness. This approach not only improves thermal performance overall, but also gives a single starting point for the entire roof as far as expected longevity and warranties.**

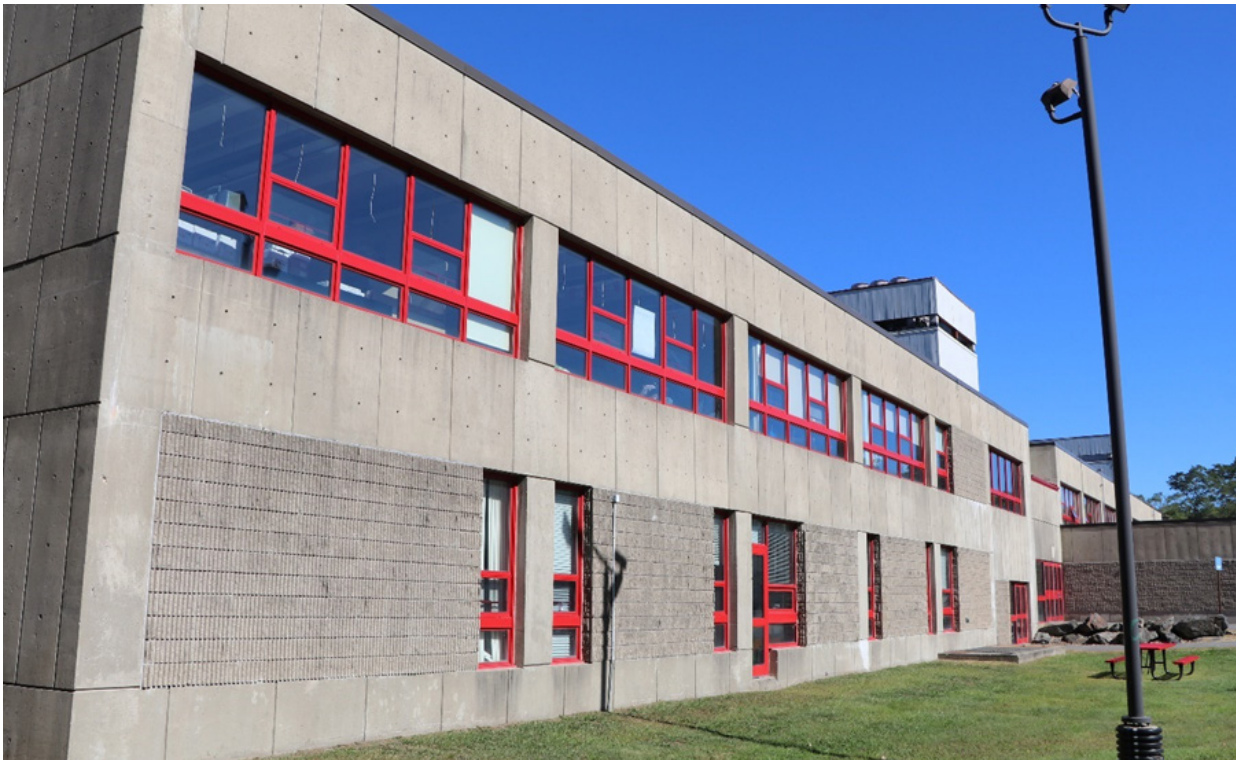
According to the educational program provided by the district, the Existing exterior walls are a combination of exposed concrete and CMU (striated) and original to the building. A visual inspection of the interior side of exterior walls suggests the walls are not insulated, however further investigation would need to be completed to confirm this. At the classroom bays, large expanses of ganged windows take about 2/3 of the façade. In general, the concrete appears to have aged well, exhibiting only the weathering and staining anticipated for a building of this vintage.

Based on available drawings, it is expected the insulating value of the current wall assembly to be low and not conform to current code requirements. As per Chapter 5- Existing Buildings, alterations to the existing building envelope shall comply with the code requirements for new construction without requiring the unaltered portions to comply with Energy Code. ( IECC 2021-C503.1)

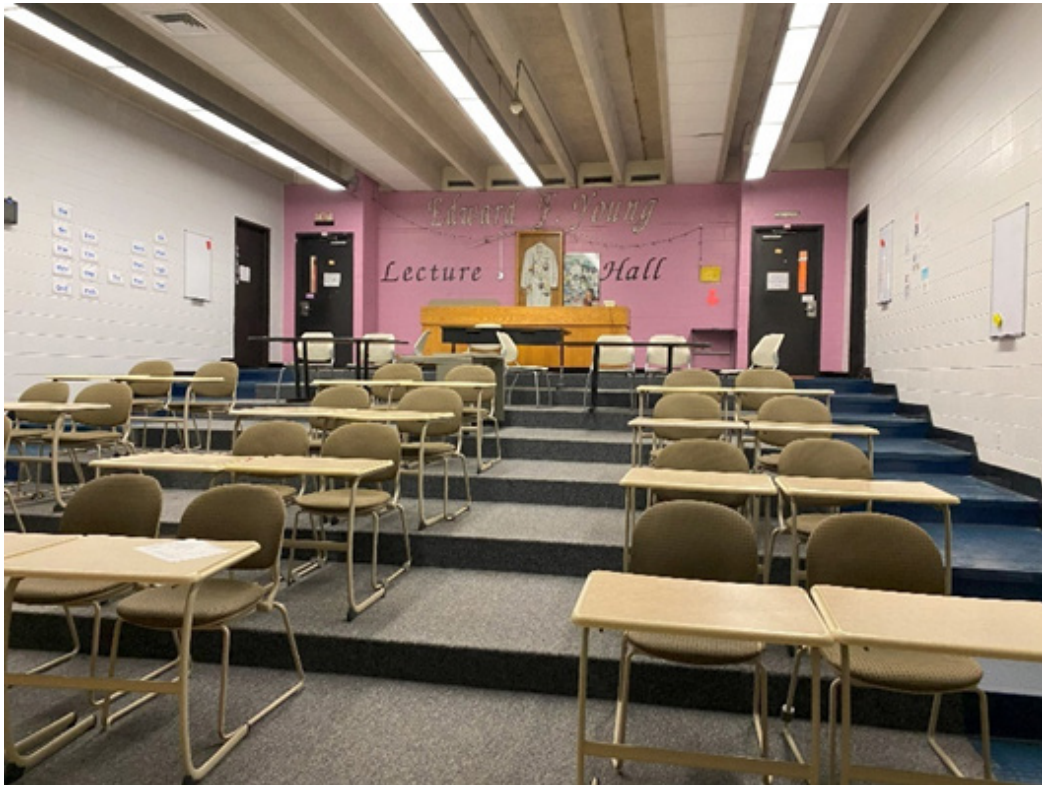
The first floor is generally in fair to good condition. Walls between room/spaces are mostly painted CMU & concrete with some newer GWB wall partitions which have been added over the years. Exterior walls are predominantly exposed concrete and concrete masonry units, ceilings are mostly exposed concrete structure with acoustic ceiling tile inserted between beams, and floors are VCT or carpet tile. Casework is outdated and not MAAB compliant. Some lecture halls or classrooms are set up as amphitheater seating, and are not fully handicap accessible.

**Renovation considerations must include casework upgrades to meet MAAB requirements and should include painting wall surfaces.**

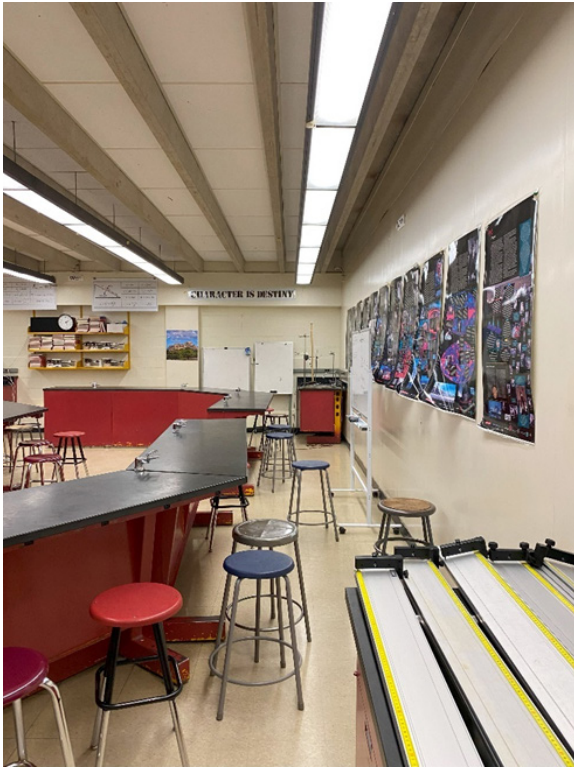
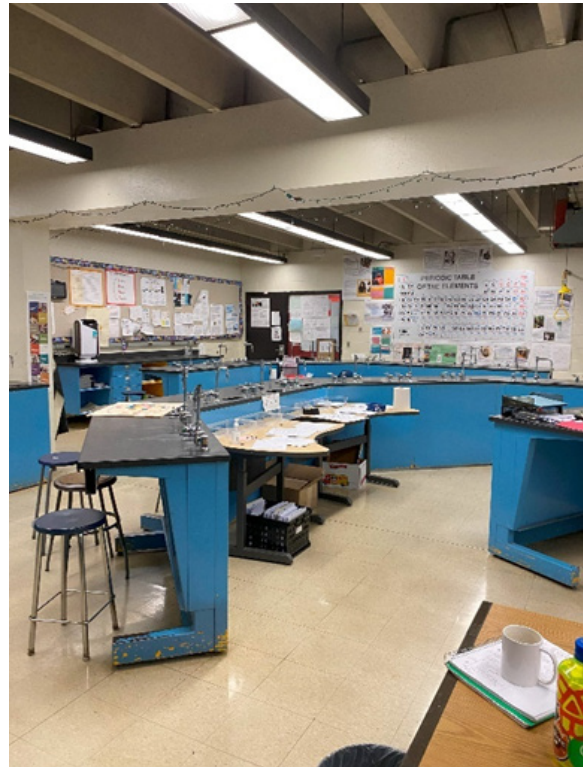
Walls between Science Classroom spaces are generally painted concrete masonry units. The science classrooms are located in the core of the building so there is no direct exposure to daylighting nor views out from windows. Ceilings are exposed concrete structure with ACT infill between beams and floors are VCT. Casework and fixed workspaces are outdated and not MAAB compliant.

**Renovation considerations must include casework upgrades to meet MAAB requirements and should include painting wall surfaces.**

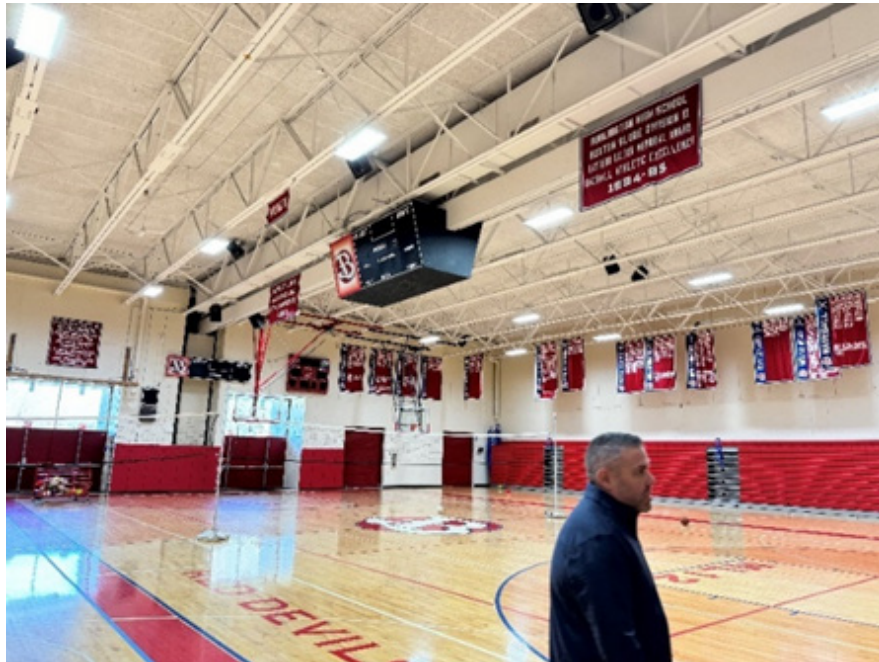
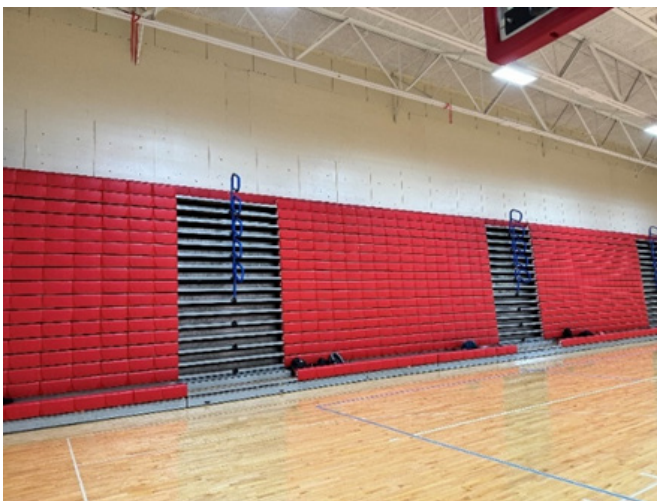
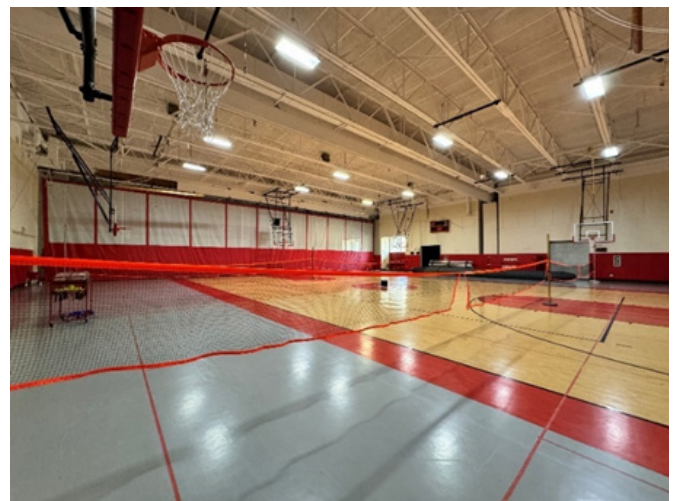
There are two gymnasiums in the building. One has a newer wood floor that is in good condition and the other has a rubber floor. Both gyms are in generally good condition. The walls are painted CMU and concrete masonry units. The gym roofs are exposed concrete structure with steel trusses. Bleachers in the wood floor gym appear to be in good condition and not outdated. Gym equipment appears functional.

**Renovation considerations should include replacement of gym equipment ( backboards, scoreboard and curtain).**

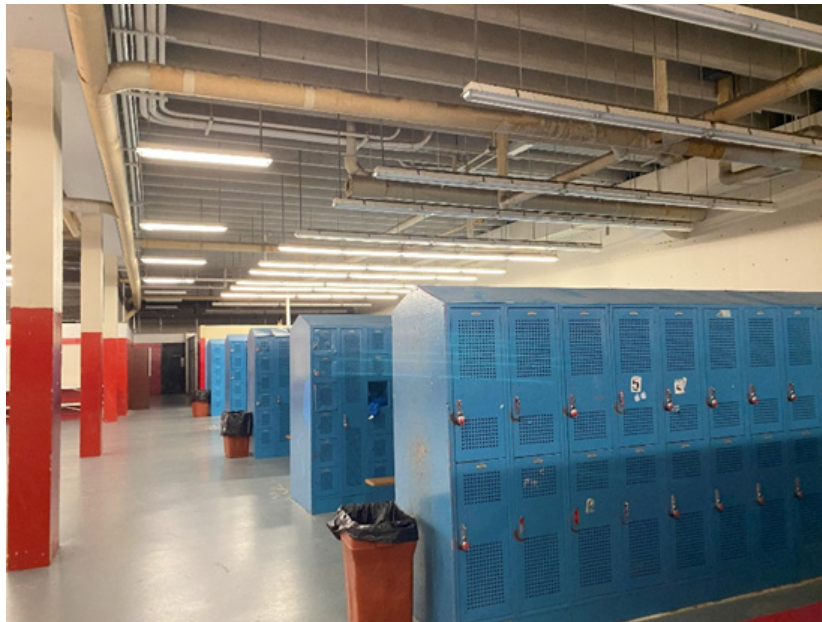
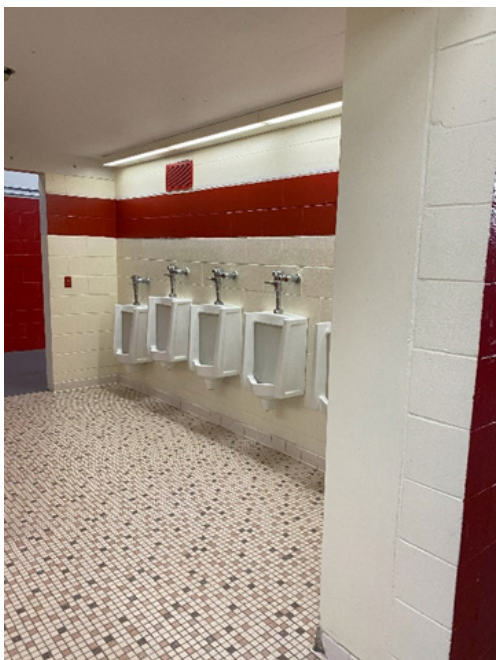
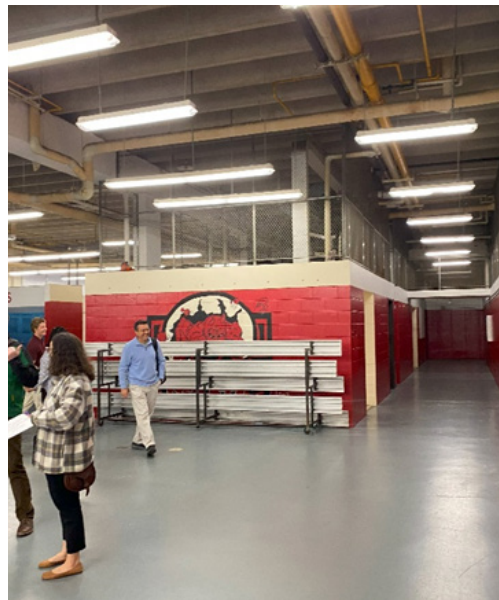
The locker rooms walls are painted concrete and CMU, and the floor is finished concrete. The bathrooms and showers attached to the locker rooms have concrete and CMU walls and mosaic tile flooring. Ceilings in the locker rooms are exposed concrete structure and painted GWB ceilings in the bathrooms. The fixtures in the bathrooms are in generally good shape though minor upgrades may be needed. Locker room renovations occurred in 2009, however the finishes have grown tired over time.

**Renovation considerations should include full reorganization and renovation of these spaces.**

**If all areas of locker rooms / showers are available to the students, HC access must be provided to comply with MAAB requirements.**

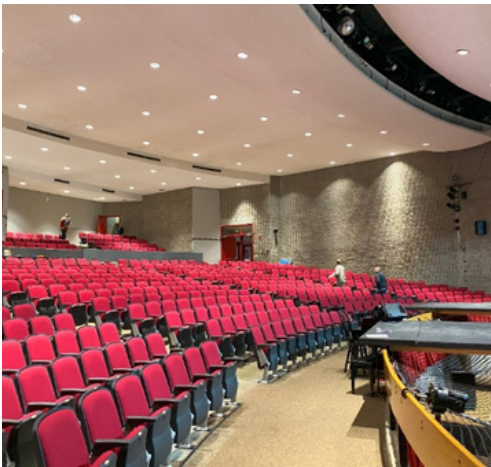
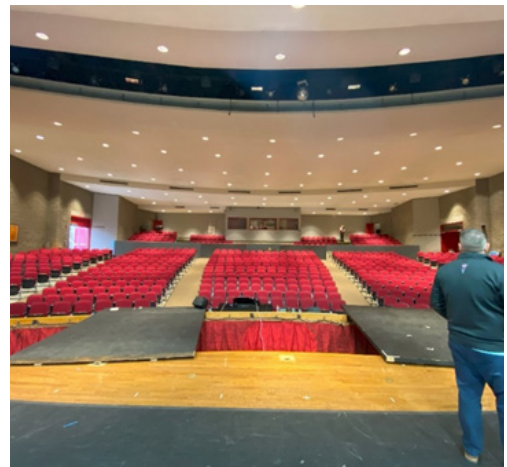
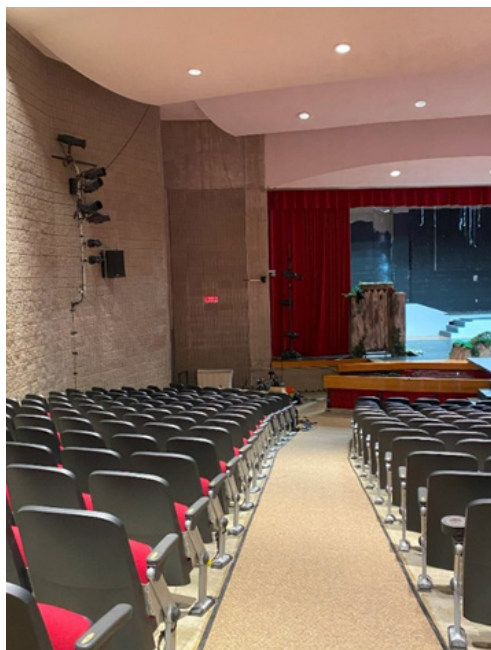
The auditorium has gone through several upgrades over the years. These upgrades include the sound system, chair replacement, and lighting controls. According to the educational program provided by the district, there is seating for approximately 800 people. Access to the stage stairs on either side, and no railings exist. The orchestra pit is below the stage with netting over the top. There is no direct accessible route onto the stage. There is an accessible route to get into the auditorium, however the path is not along the typical student path. Walls are made of striated CMU and the ceiling have acoustic paneling

**If the control room is open to the students, HC access must be provided to comply with MAAB requirements.**

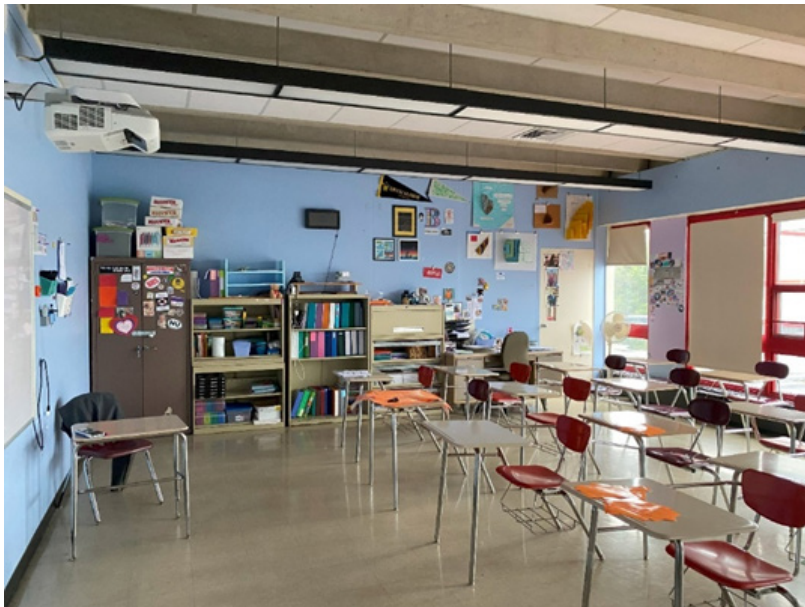
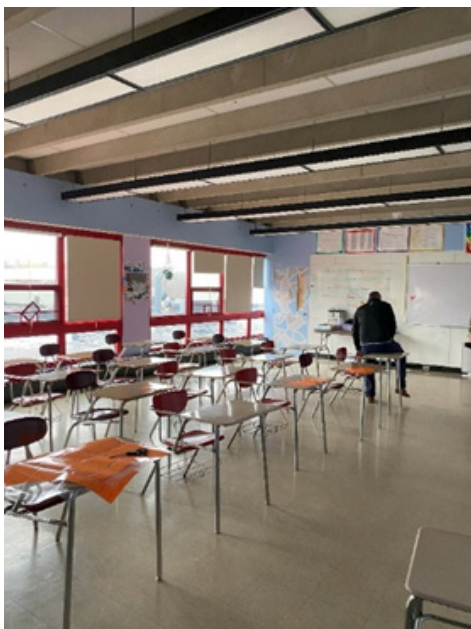
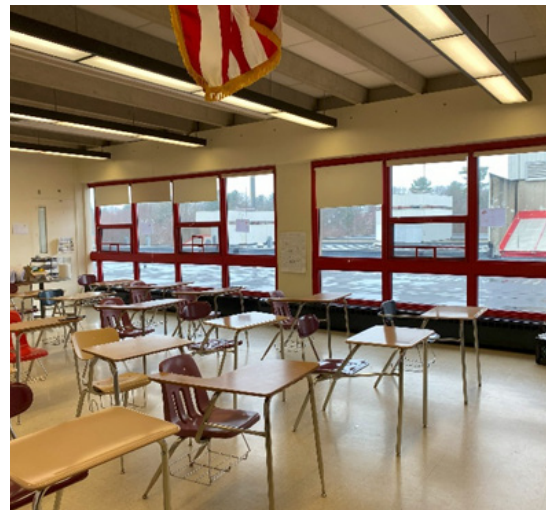
Not every classroom at this floor has storage casework.

Wall mounted projectors rely on the existing markerboards for the quality of their images. MB surfaces are in fair condition. If the technology proposed for visual devices continues to rely on markerboard for projection (such as a wall or ceiling mounted projector) it is recommended to replace existing with a whiteboard surface that is optimized for projection, with minimal glare or reflection.

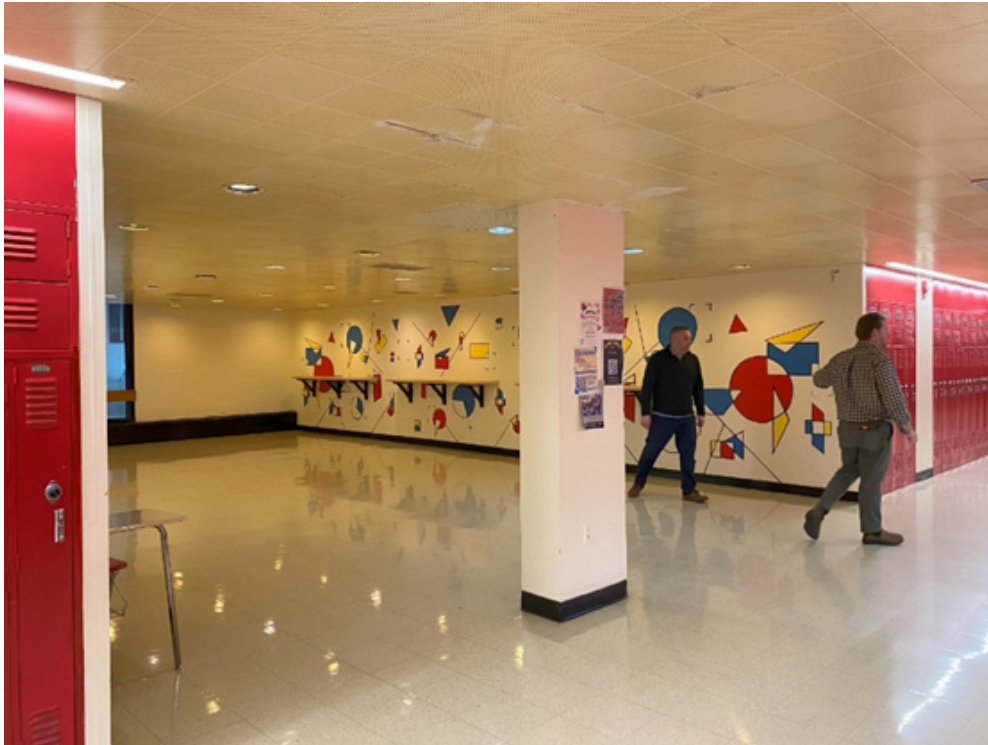
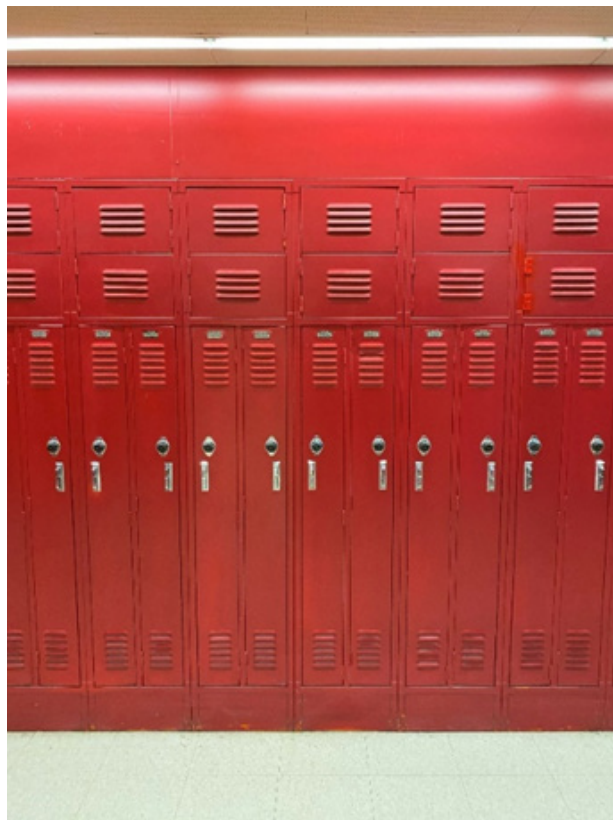
Finish Materials - VCT, ACT and structural glazed tile / plaster look in fair to good condition.

Corridors at the second floor(s) have VCT flooring, perforated tile ceiling and exposed structural concrete ceilings, and the walls are Painted CMU or lined with recessed lockers (See Classrooms section above). The finishes appear to be in fair condition but are growing tired.

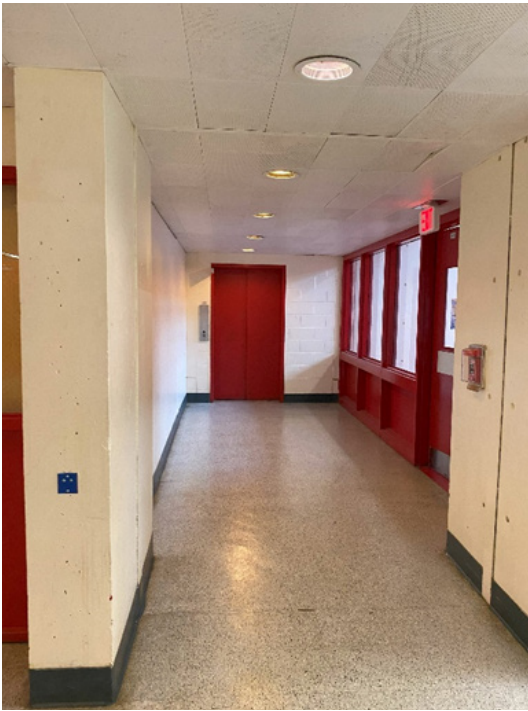
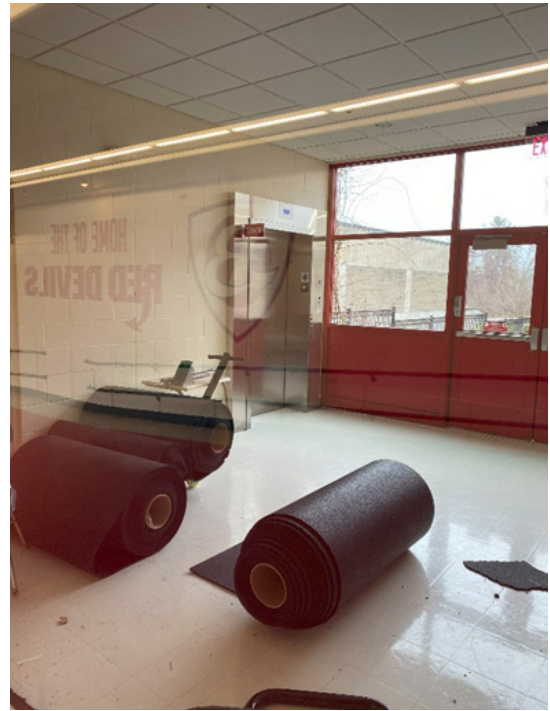
Currently many of the room signs are mounted on the doors, which is not in compliance with MAAB.

**Signage needs replacement to meet MAAB requirements and to address proposed room numbering.**

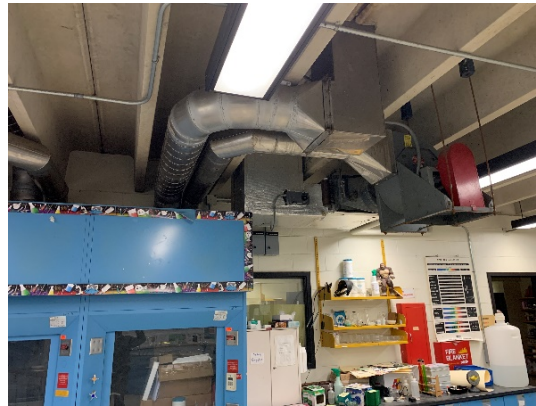
Photo 4 – Exhaust Hood with Make-up Air Fan

The science classrooms are provided with chemical exhaust hoods with controls and make-up air systems that do not appear to be functioning and appear to have failed.

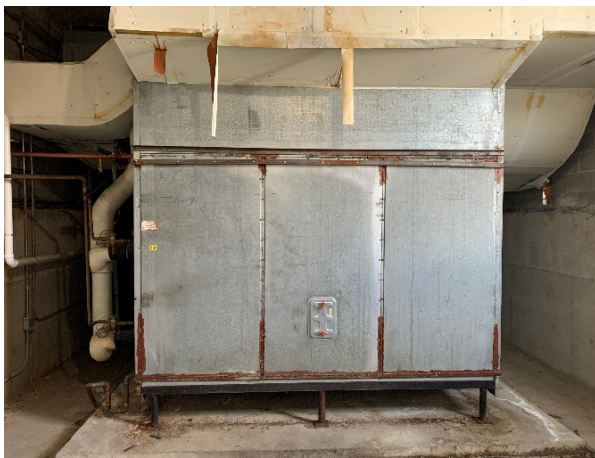
Photo 6 – Penthouse Air Handling Unit

The Classrooms, Administration area, Library, Auditorium, and Cafeteria are provided with heating, ventilating and air conditioning rooftop air handling units with hot water heating hot deck/DX cooling air cold deck and return fans located in roof level mechanical penthouses. All units are original to the building and appear to be in disrepair. Each rooftop unit is provided with an air-cooled condensing unit on the top of the mechanical penthouse. Rooftop air handling units provide air through separate ductwork distribution to dual duct variable air volume terminal units that mix the cold deck/hot deck for individual zone space temperature control. The ceiling space within each zone is used as a return air plenum. Each zone has been provided with a space sensor. All spaces have also been provided with fintube radiation at the exterior walls to provide supplemental heating.

Main heating equipment and rooftop air handling equipment serving the classrooms, administration area, library, auditorium, and cafeteria will be replaced with new, high efficiency equipment with new air-cooled condensing unit and energy recovery to meet new energy conservation codes.

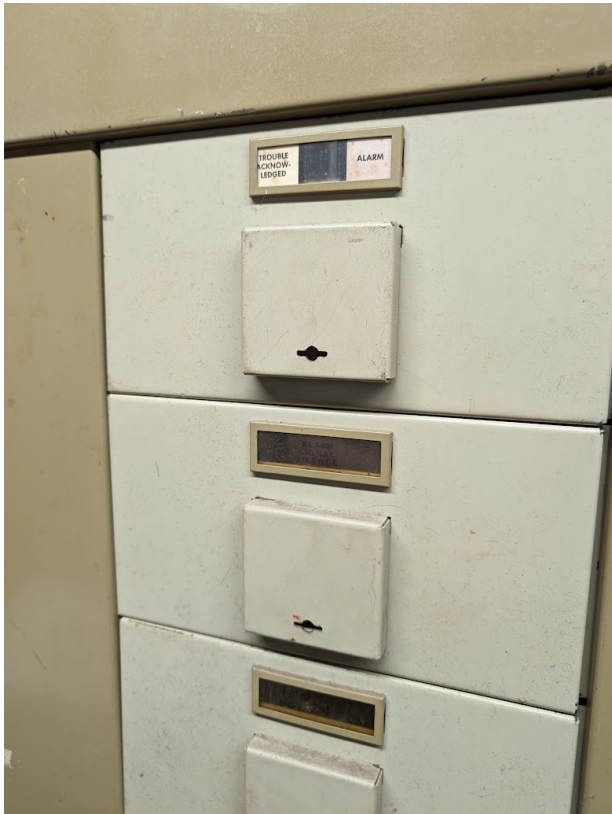
Figure 6 FATC.

The existing fire alarm system was very old. The exact date could not be confirmed. The system had been upgraded in parts, but the system remained dated. It is recommended that a new fire alarm system be provided.

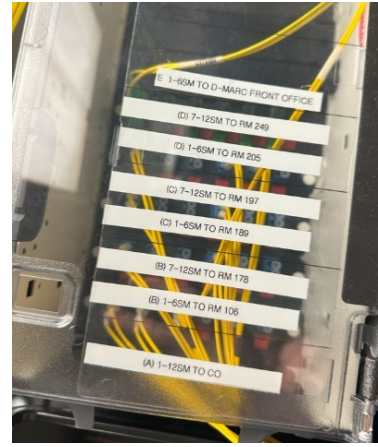
*MDF Fiber breakdown*

Data cabling is mostly a combination of legacy Category 5 and Category 5e. There are several instances of exposed fiber and cabling throughout the building.

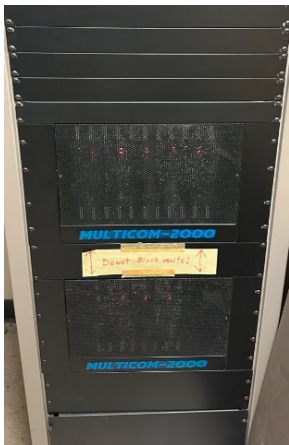
*Bogen Multicom-2000 Equipment*

The school also contains a legacy but functional Bogen Multicom-2000 public address system located adjacent to the library. The school uses an on-premise Cisco VoIP system. Classrooms have one analog phone which functions as a call button, and one Cisco VoIP handset used for inerschool and outside communication.

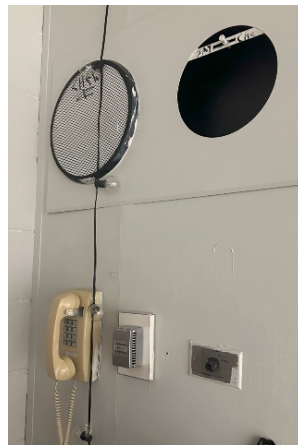
*Typical classroom PA phone / speaker*

Public address speakers are of an older vintage and spacing is inadequate for proper coverage. New public address endpoints should be considered as part of any new building project. Clocks have been sporadically replaced with battery operated clocks.

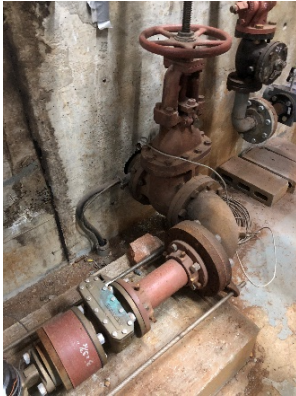
Photo 1 - Water Service

The building's domestic water is supplied underground through a four-inch (4") ductile iron service. The four-inch (4") domestic water supply is equipped with a strainer, isolation valves, and a 2" meter. The water service piping is a mixture of ductile iron and copper, appears to be in good condition.

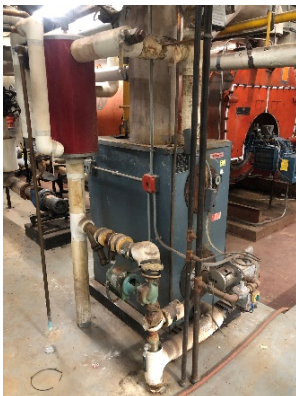
Photo 3 - Water Heater

The main domestic water heating plant is located in the mechanical room and consists of an H.B. Smith model G81-1735 gas-fired cast iron boiler with an Everhot model 16 indirect water heater. Heated water is stored in one the original Patterson-Kelley Control-Flo 500 tank-type indirect water heaters. The domestic hot water system appears to be a recirculated single temperature system. A thermostatic mixing valve could not be found. The piping around the water heater and storage tank is in good condition.

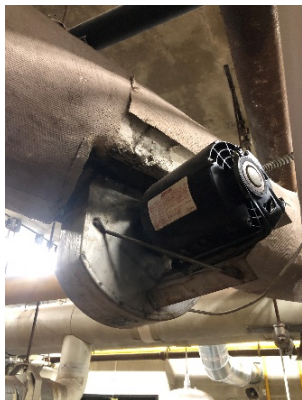
Photo 5 – Draft Inducer Fan

The boiler vent piping is insulated single wall galvanized steel and has been retrofitted with a draft inducer fan. The water heating boiler is common vented with the heating system boilers to a masonry chimney.

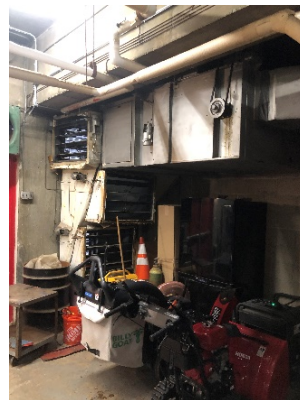
Photo 6 – Combustion Air

Combustion air is provided by an exterior louver with high and low openings with motorized dampers as well as an air handling unit. It is unknown how these are interlocked with the boilers and water heater.

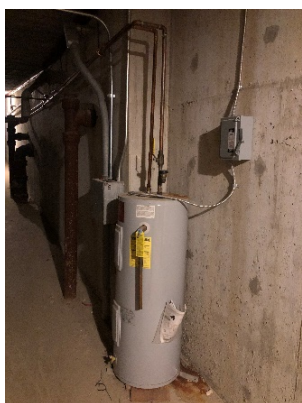
Photo 7 – Electric Water Heater

There is a 30-gallon State model ES630DORT electric water heater located in the basement corridor which appears to serve the science classrooms. There is a small electric water heater (nameplate data not accessible) which serves the early childhood wing. There is also a State model SBD-81-199NE gas-fired atmospheric water heater which serves the kitchen.

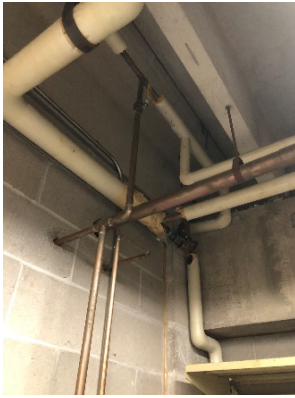
Photo 9 – Water Piping

Only the exposed piping scattered throughout the building could be observed and evaluated. The domestic water piping is hard drawn copper tube and appears to be in fair to good condition, with some evidence of previous leaks. New piping and repairs have been done with copper tube and pressed fittings.

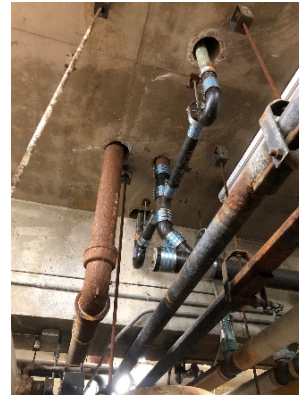
Photo 10- Sanitary & Storm Drain Piping

What could be seen of the existing sanitary drain, waste and vent system appears to be a combination of drainage pattern copper and cast iron. The majority of the piping is hub and spigot cast iron with either gasketed or leaded and caulked joints, with some no-hub cast iron pipe with rubber couplings and stainless steel bands with shields. Copper drainage piping is limited primarily to fixture connections. Visible piping appeared to be in good condition, with little evidence of active leaks.

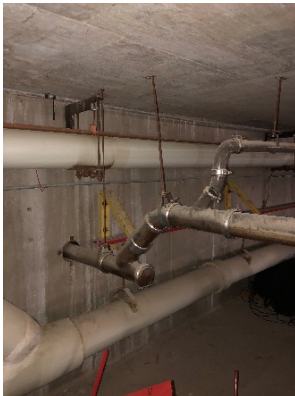
Photo 11 – Glass Waste Piping

Waste and vent piping serving the science classrooms is primarily glass with stainless steel band clamp couplings with some polypropylene pipe with mechanical or heat fused joints and fittings used for repairs. There was no evidence of an acid neutralization or pH adjustment system.

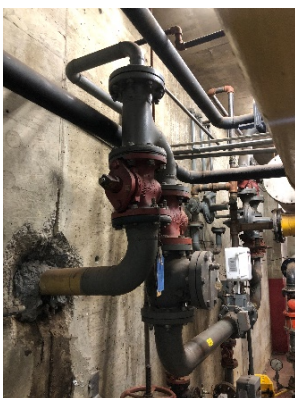
Photo 13 – Gas Service

The building is equipped with a natural gas service located inside the boiler room. The natural gas system serves the domestic water heater, building heating equipment, kitchen equipment, and science classrooms. The kitchens and science classrooms do not appear to be equipped with emergency gas shutoffs, and the kitchen system does not appear to be interlocked with the kitchen exhaust. Gas piping is steel with welded or threaded fittings, and appears to be in good condition. MegaPress fittings have been used for repairs.

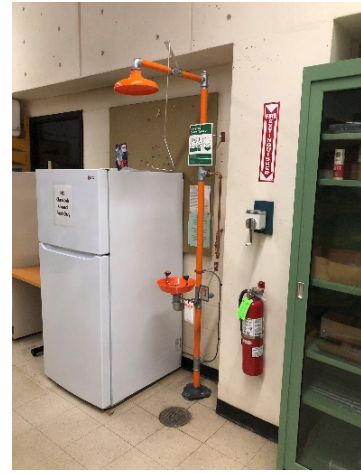
Lab Cup Sink

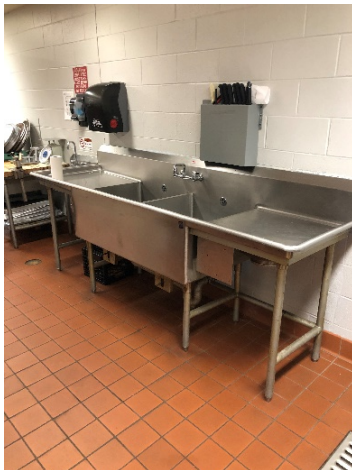
Scullery Sink

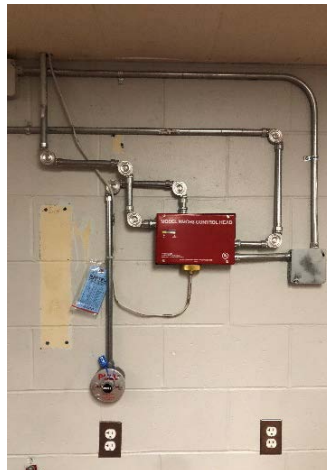
Emergency Shut-Off

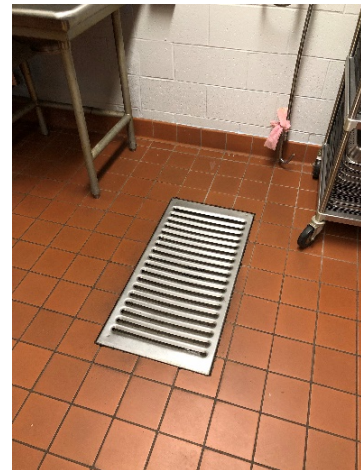
Trough Drain

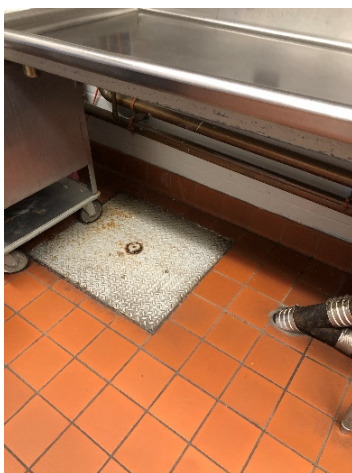
Grease Interceptor

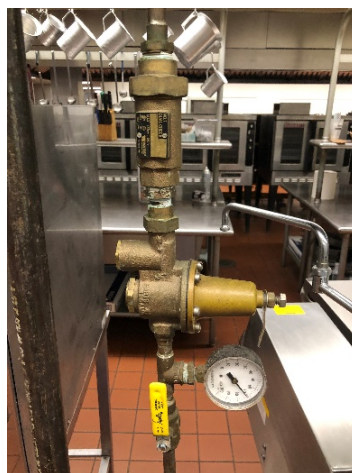
Dual Check & PRV

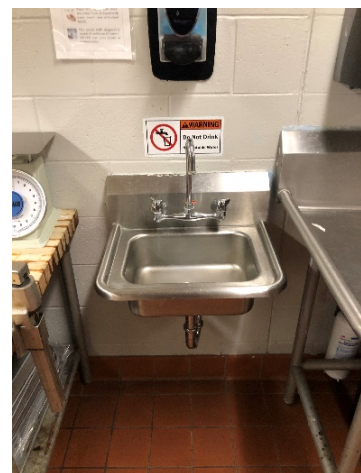
Hand Wash Sink

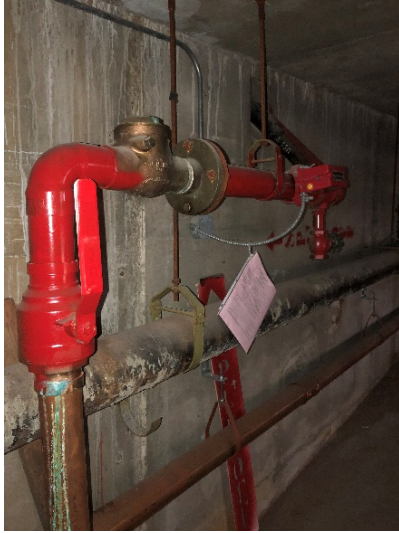
There is a limited area sprinkler system which is tapped off of the domestic cold water piping in the basement. The sprinkler system serves the stage and adjacent storage room, and includes 2½" valved hose connections on either side of the proscenium.

Photo 1 – Sprinkler Service

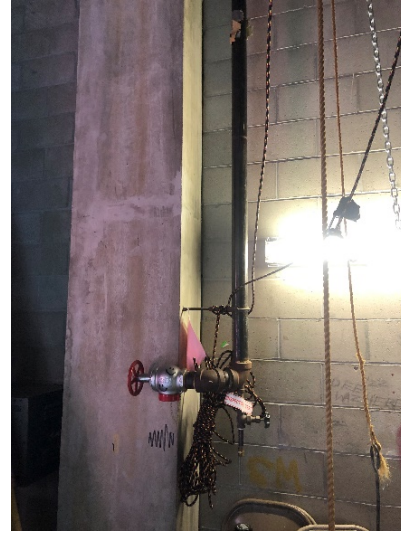
Photo 2- Stage Hose Connection

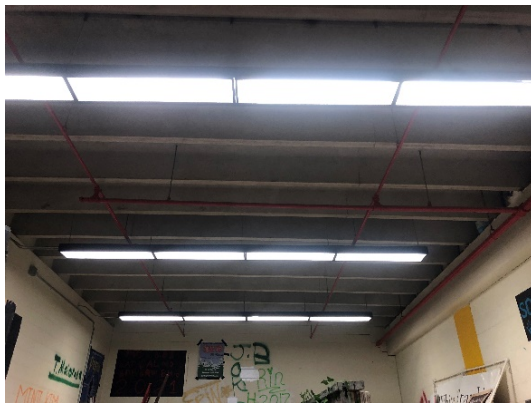
Photo 3 – Storage Room Sprinklers

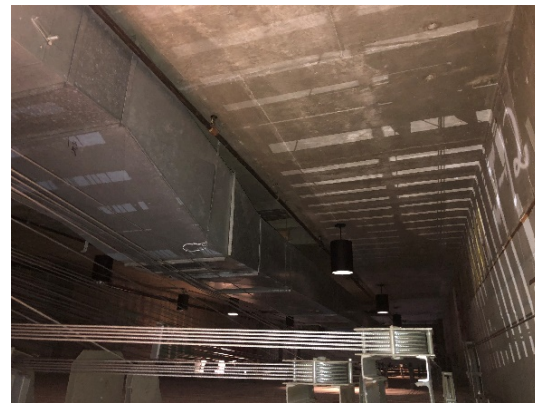
Photo 4- Sprinklers above Stage
